BAYOU VISTA CANAL

BAYOU VISTA CANAL COORDINATES

BAYOU VISTA CANAL MAPS

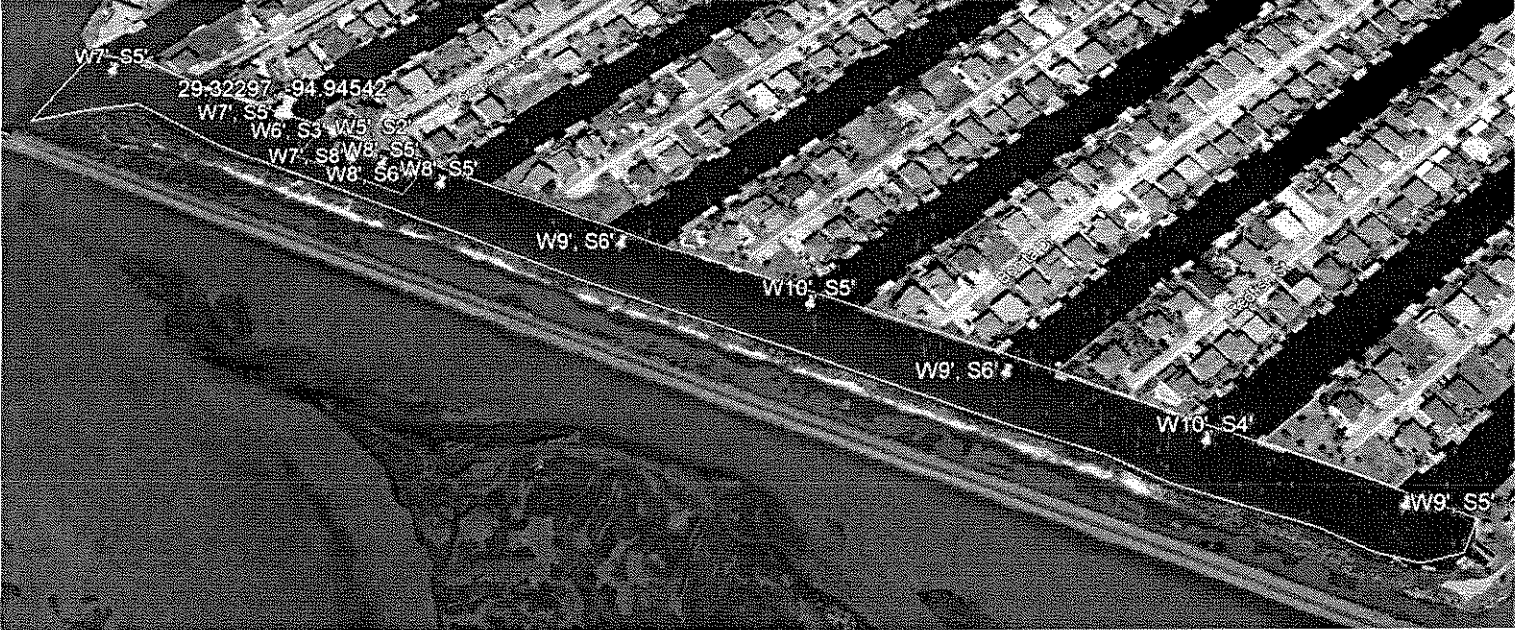
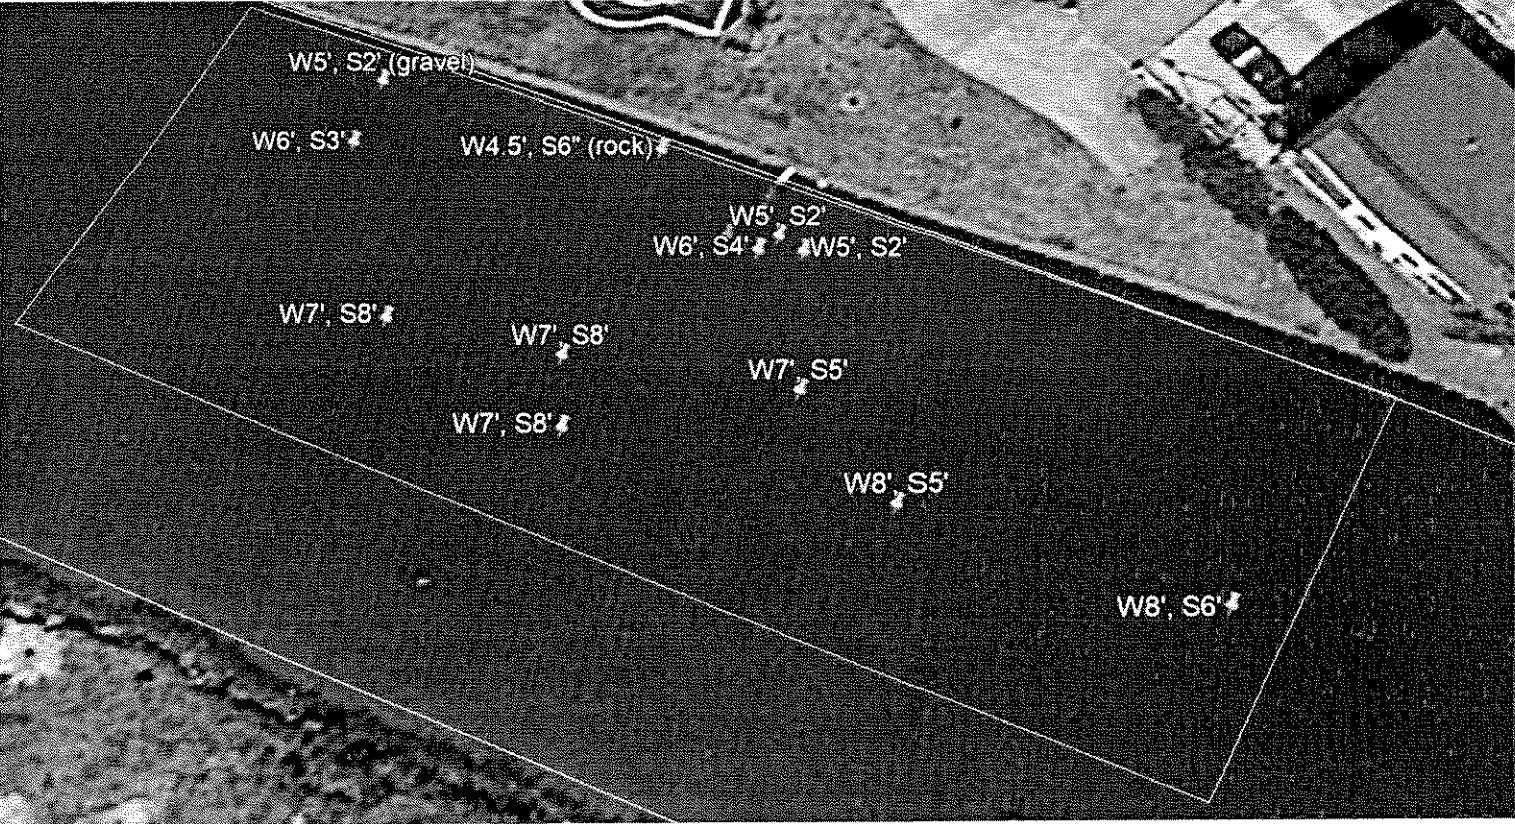
The attached drawings and tables depict the results of our survey, and the data collected was used to provide an estimate of the current water storage volume and the amount accumulated soft sediment within the defined area. This unconsolidated sediment layer is comprised of soil particles and organic materials that have accumulated on the bottom of the waterbody, which remain penetrable by a manual depth sampling instrument. A manual probe was used to measure the remaining water depth and magnitude of unconsolidated sediment depth at each data point down to the hard bottom. A total of 22 measures were taken in the areas of greatest concern as defined by the customer and location of each data point was marked using a GPS handheld device. The information gathered was input to create a crude map on Google Earth of the remaining water depths and sediment accumulation at each location. The estimated total volume of unconsolidated sediment in area(s) of concern was derived by using an average of the measurements recorded at each data point. The table below shows the results.

Surface area of canal	7 acres (311,774 square feet)
Maximum water depth observed	10 feet
Average water depth	7 feet
Maximum sediment depth observed	8 feet
Average sediment depth at intersections of canals	5 feet
Average sediment depth at area of pipe	4.9 feet
Estimated sediment volume at area of pipe 17,000 sf	3,085 cubic yards
Estimated sediment volume of entire canal	57,735 cubic yards
Maximum depth observed from surface to hard bottom	15 feet

case of Bayou Vista Canals, sedimentation can also be a result of moving tides and currents. Currently, there is sufficient water depth for recreational boats to maneuver in and out of the canal. As additional sedimentation occurs, the water depth will decrease and impede the passage of boats. It is our recommendation that reserve funds always be set aside for regular maintenance dredging.
